**ADDENDUM NO. 1
TO THE PLANS, SPECIFICATIONS, PROPOSAL AND CONTRACT FOR
SILVER LAKE WATER AND SEWER DISTRICT**

**Reservoir No. 4 Roof Recoating
Project No.: 24-0001**

DAILY INSPECTION REPORT

Date:	Wednesday 10-12-2022	Client:	Silver Lake Water District	Contractor:	NA
Project:	Roof Inspection	Phase:	Inspection	Inspector:	Michael Murphy

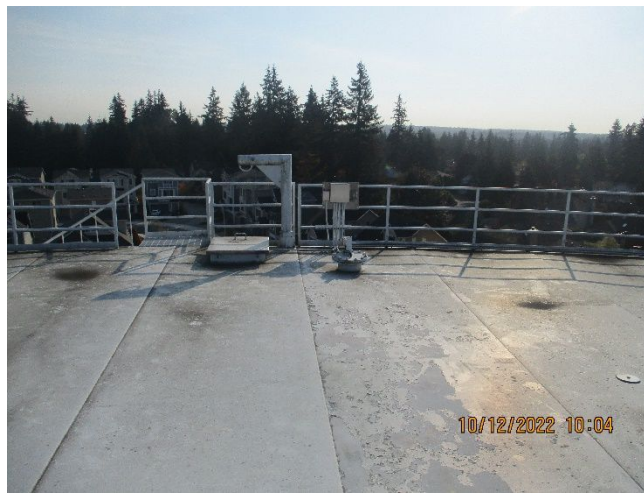
10:55 AM	<p>I have completed my Inspection on the roof and my observations are the Following:</p> <ul style="list-style-type: none"> ➤ There are areas throughout the roof where the topcoat has delaminated from the mid coat ➤ The largest areas of delamination are near the roof access/staircase and North side of the tank near the cell towers ➤ The underlying coats (Primer and Intermediate) are still intact and providing protection to the substrate ➤ There is one spot, at the top of the staircase, near the roof hatch where some spot rusting is occurring. The topcoat in this area has delaminated, exposing the epoxy mid coat. It appears that the epoxy mid coat was rolled on, and in this area not enough epoxy was applied creating holidays in the coating. The holidays exposed the substrate/zinc primer resulting in pinpoint rusting. The zinc primer is providing protection by slowing down the rate of corrosion. ➤ There is black matter where the topcoat is delaminating. Whatever this substance is, it appears is the cause of the topcoat failure. It appears to have no affect on the underlying coating.

11:00 AM	<p>I am now leaving site.</p> <p>Summation (Sonny Mauricio)</p> <p>As stated in the above information provided by Mike Murphy, I agree with the assessment. The substance on the roof, most likely bird droppings, is attacking the topcoat causing it to delaminate from the underlying coat. There are several options I see moving forward which are as follows:</p> <p>Option #1 – Do nothing and reassess the roof coatings in 5 years</p> <p>Option #2 – I believe the topcoat is Tnemec Series 73. It would be easy to pressure wash to remove contaminants and loose coatings, make any spot repairs as needed with an epoxy, then overcoat with Series 73.</p> <p>Option #3 – I spoke with Tnemec about another option. Rick Gilbreath mentioned that their Series 290 would be a good option to repair the roof if the district were to go with this option. Series 290 is chemical, immersion resistant if there is any ponding on the roof. Tnemec can provide a procedure, however, it would look something the following:</p> <ul style="list-style-type: none"> • Pressure wash to remove contaminants and loose coatings • Sanding of the remaining coatings • Applying a thin coat of the 290 <p>If there are any questions of the options laid out please don't hesitate to call or email.</p>

PHOTO 1 Example of Topcoat delamination

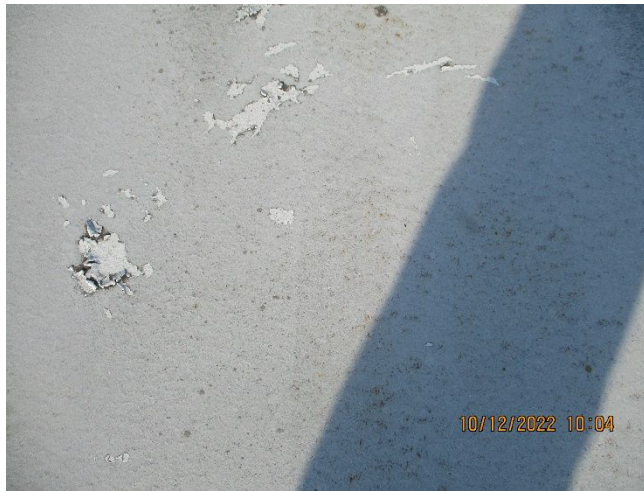
PHOTO 2 small areas of delamination

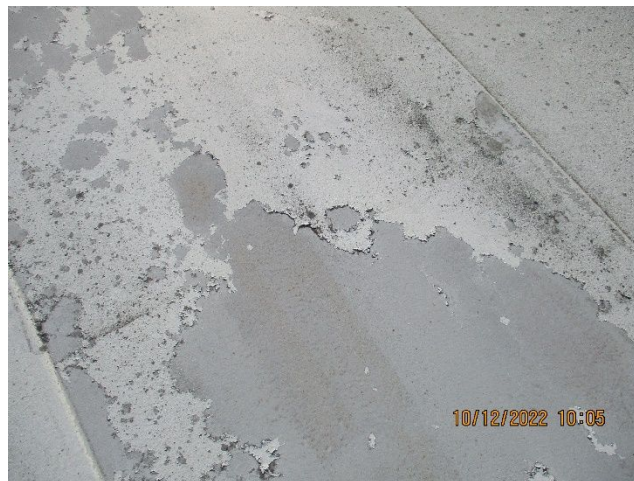
PHOTO 3 Delamination of Topcoat

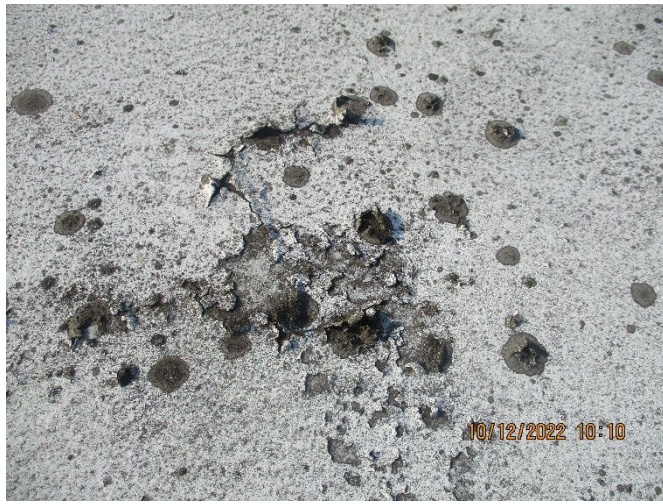
PHOTO 4 areas prior to scapping

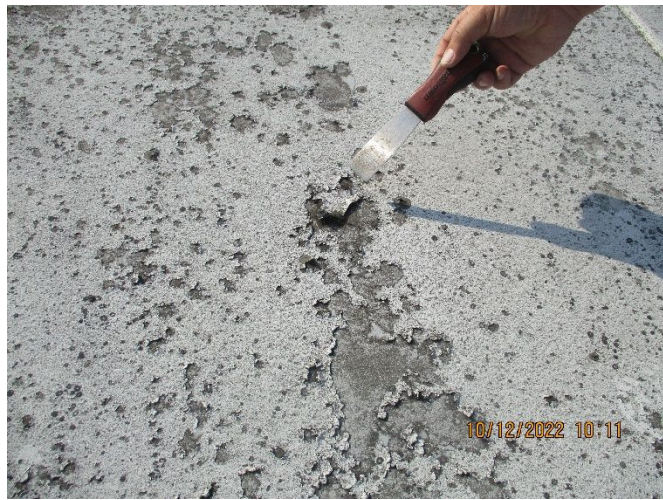
PHOTO 5 scapping off Topcoat

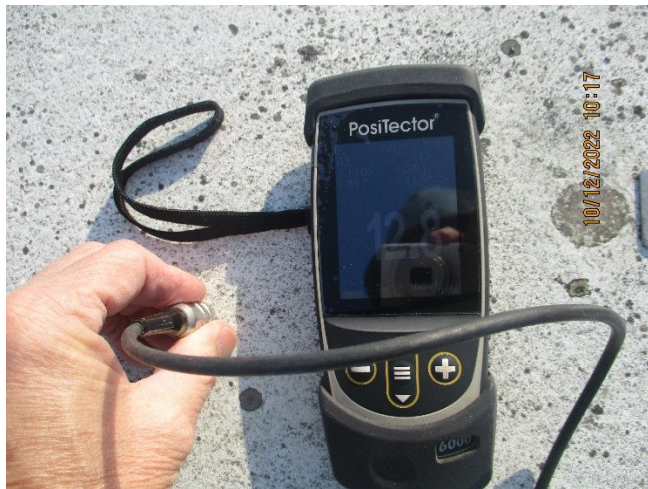
PHOTO 6 Dry Film Thickness Measurement

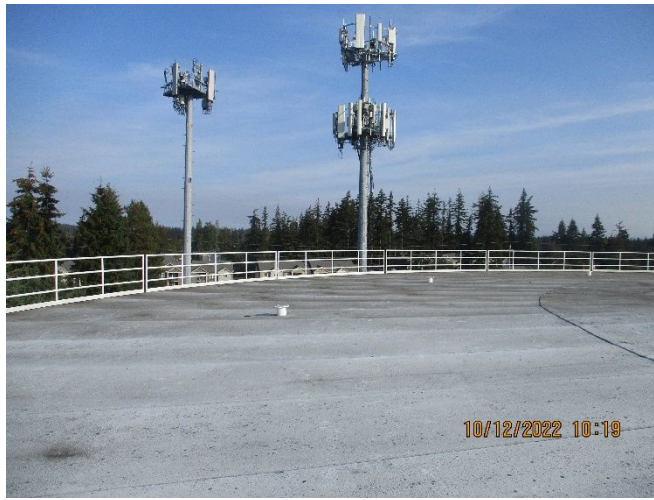
PHOTO 7 Cell Towers where Birds have Nesting

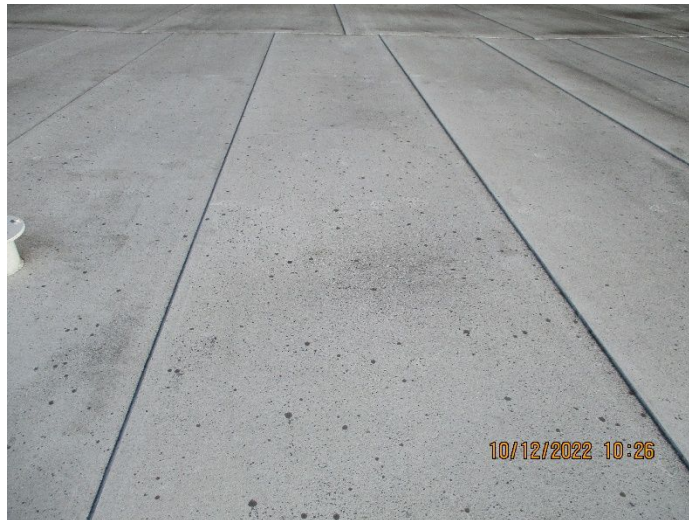
PHOTO 8 View of Random spots of Delaminations of Topcoat

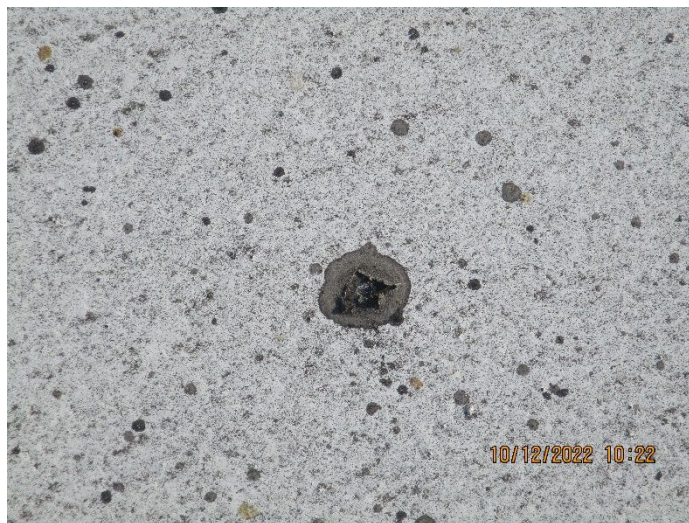
PHOTO 9 Closeup of area

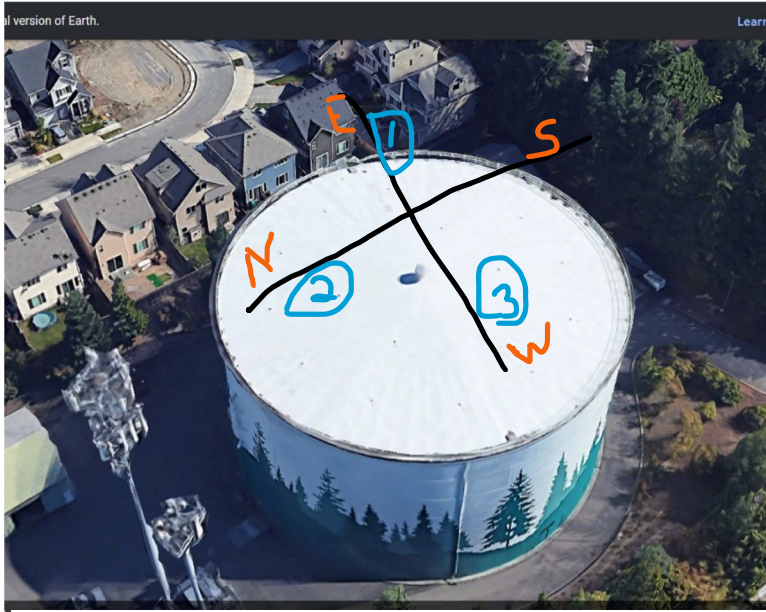
PHOTO 10 View of Roof Top Areas of largest delamination of Topcoat
